# Manhole Inspection Summary

Manhole # S29SS\_012MH

Insp Date: **8/6/08 9:34 AM**

**Location** Address: **2801 FALLS RD**

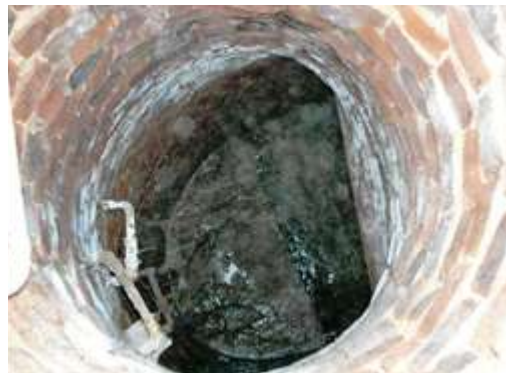
Top View

**Steps** Count: **6** Missing: **0** ☒ **Corroded**

Corroded steps.

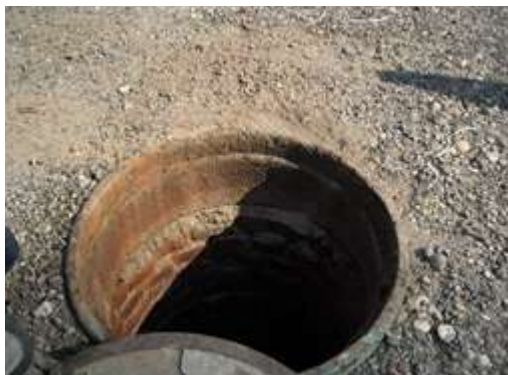
MISC.

Subject To Ponding: **Sheeting**

Infiltration: ☐ None ☐ Joint ☐ Cracks ☐ Mortar ☐ Roots ☒ **Wall**

INFLOW EVIDENCE FROM SHEETING

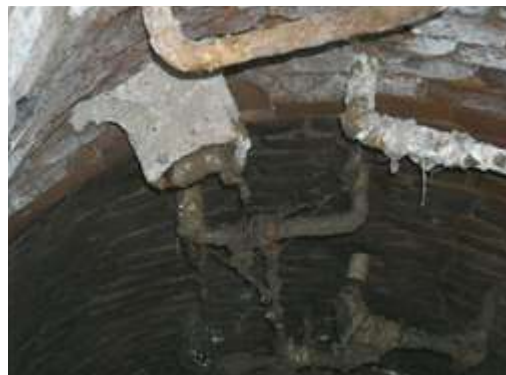
MISC.

PIPE THROUGH CORBEL WALL

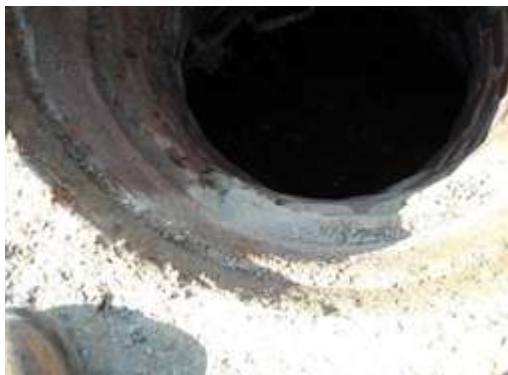
Defect

**Frame** Offset: **1** (in.) Condition: ☒ Sound ☐ Cracked ☐ Leaks

FRAME OFFSET

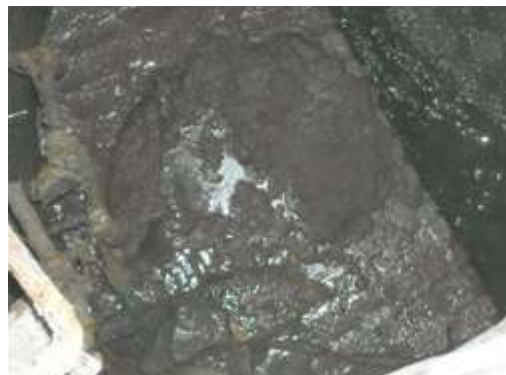
Defect

**Bench** ☒ Exists Material: **Brick** ☐ Parged ☒ **Debris** (not Condition related)

Condition: ☐ Sound ☐ Cracked ☐ Root Intrusion ☐ Deteriorated ☐ Leaks ☒ **Debris**

DEBRIS ON BENCH

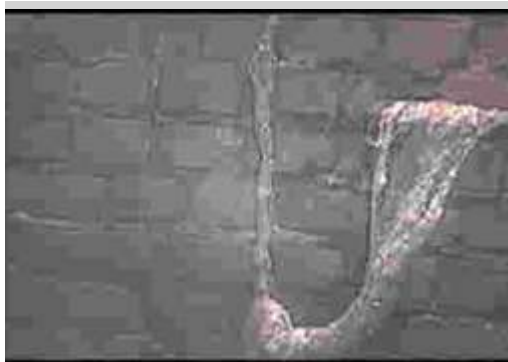
Defect

**Surcharge** ☒ **Evidence Of Surcharge** Depth: **6** (ft.) ☐ Active Surcharge Present

SURCHARGE EVIDENCE

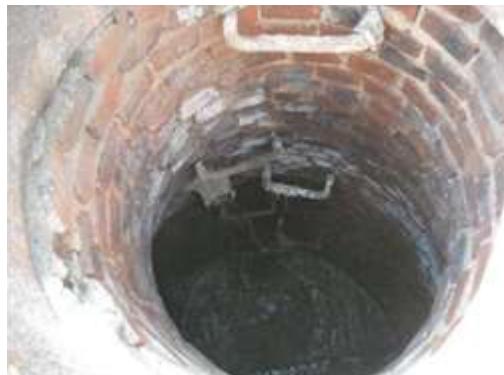
Defect

CORRODED STEPS

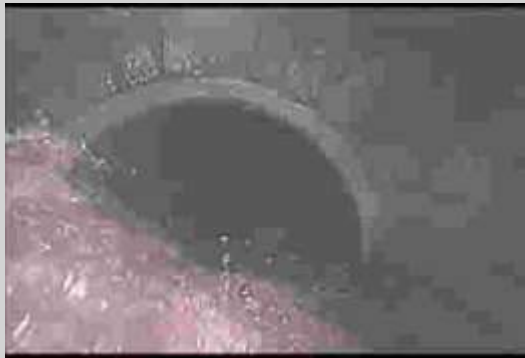
### 27 in. Circular Gravity Sewer Pipe Out @ 12 O'Clock

Invert Depth: **13.60** (ft.) Flow Characteristics: **Turbulent**

Deposits: ☒ None ☐ Mud ☐ ~~Gravy~~ ☐ Debris ☐ Grease

Infiltration: **None** Pipe Seal Cond: **Sound**

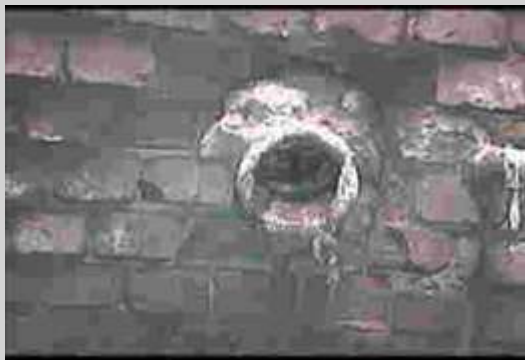
4 in. Circular Gravity Sewer  
Pipe In @ 7 O'Clock

Pipe Material: **Clay** ☐ Pipe Lined

Invert Depth: **5.19** (ft.) Flow Characteristics: **Slow**

Deposits: ☐ None ☐ Mud ☒ **Sludge** ☐ Debris ☒ **Grease**

Silt Depth: **2** (in.) Deposits Extent: **Heavy**

☒ **Possible Illicit Connection**
